Intel[®] Pentium[®] 4 Processor on 90 nm Process

Specification Update

April 2006

Document Number: 302352-028

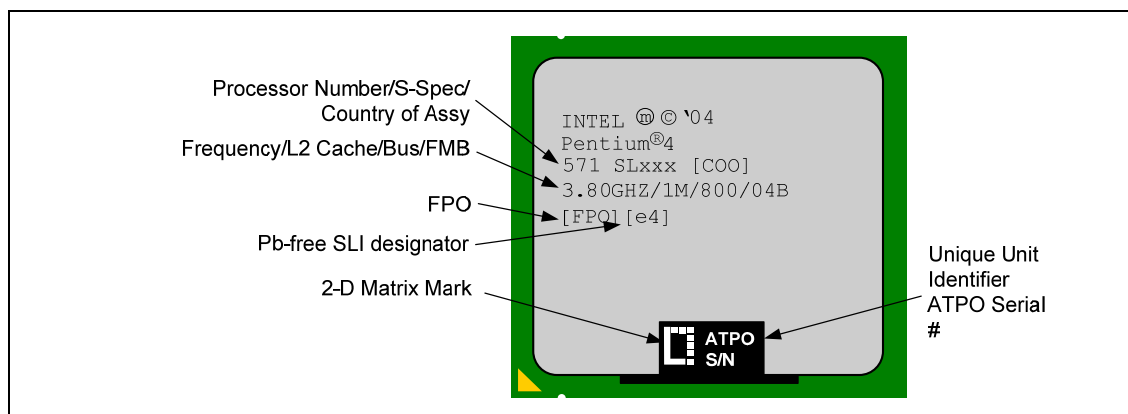
Figure 3. Intel® Pentium® 4 Processors 571, 561, 551, 541, 531 and 521^A Supporting Hyper-Threading Technology on 90 nm Process in the 775-Land LGA Package

| Revision Number | Description | Date |
|---|---|---|
| -025 | <ul style="list-style-type: none"> Updated erratum R17 and added errata R111-R114, updated processor identification table, updated figure 3 and figure 4 to show Pb-free marking | January 2006 |
